# Brows Pasture Chapel-le-Dale

## Update

(And details of associated Monastic Boundaries)

# Update to Brows Pasture Report

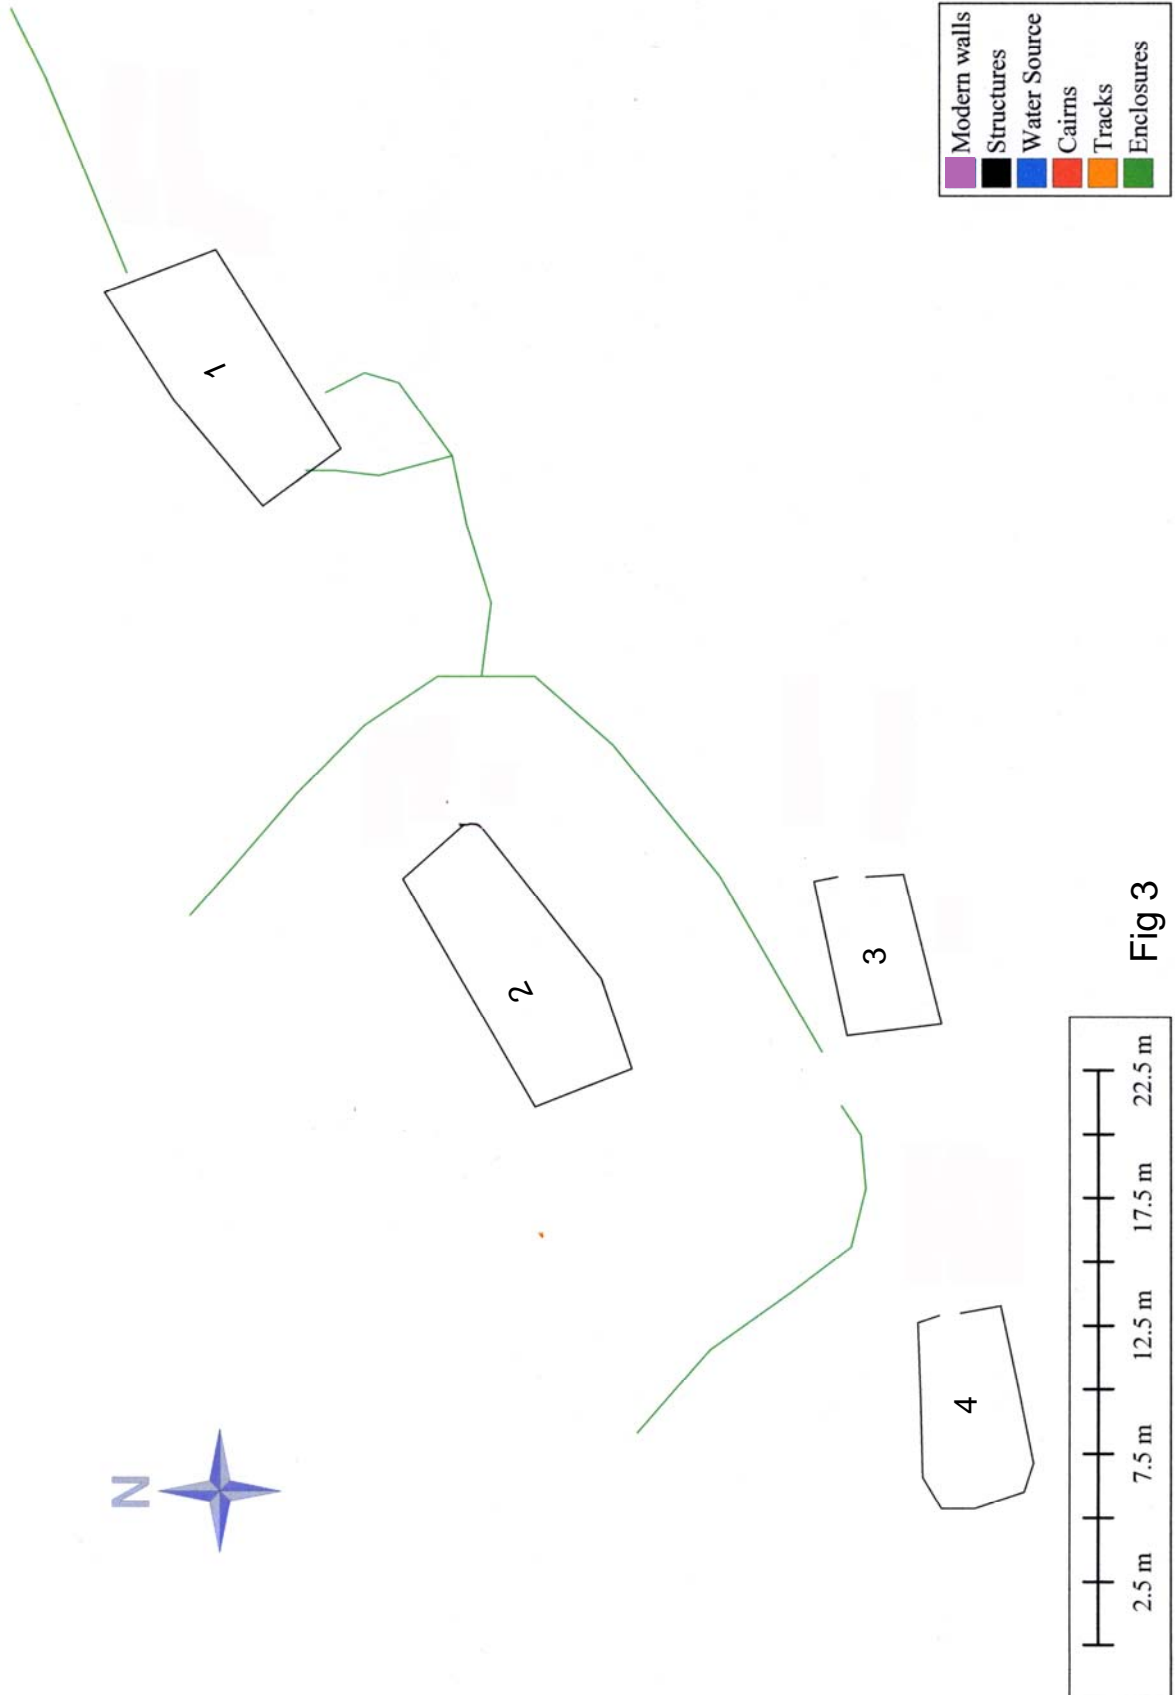
Fig 3

Area 2

Area 2, is situated beneath a steeply sloping limestone scree, and is in a more sheltered location than Area 1. Structures 1, and 2/Area 2 are connected by enclosure remains (Fig 3) that continue NE from the end of Structure 1 to a water supply. A considerable amount of stone clearance has taken place on this area of Brows Pasture and a large amount of it has been deposited adjacent to the NE gable-end wall of Structure 1 this gable has substantial wall remains approximately 1m wide, and probably suggests that the roof was hipped. There does not appear to be any reason to believe that this structure was constructed differently to those previously described. The paved floor area has a striking resemblance to those excavated in Structure 1/Area 1. An angle backed knife was also found identical in design, but slightly smaller, than the one found by the authors in same structure.

This structure is positioned to the SW of Structure 1/Area 2, below a continuation of the same scree slope (Fig 3) . The structure is within a small enclosure, possibly a kitchen garden, that abuts the scree slope beyond its NE and SW ends. There is an entrance into this area at the southern corner which was excavated and shown to be roughly paved. The entrance into the main structure is difficult to define. We tend to think this may also be located in the southern corner being the shortest distance between this point and the entrance into the enclosure. On the outside of the enclosure and adjacent to the entrance are two smaller, and less substantial, rectangular remains (Structures 3 and 4). Their location and more fragile appearance is suggestive of small livestock housing or enclosure. Being near the supposed dwelling this would make it a logical site for livestock that would be subject to predation and an ideal location for a guard dog.

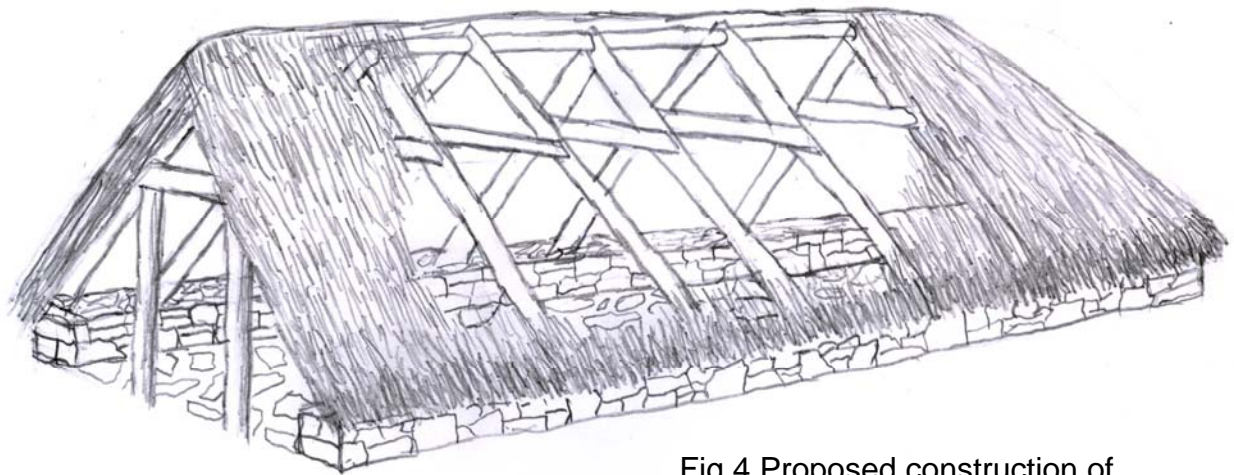
Fig 4 Proposed construction of  
Area 1/Structure 1.

The evidence suggests to us that the roof has been constructed on a low stone wall base, possibly no more than 1m wide 1m high the drawing Fig4 shows the proposed reconstruction. There are no vertical posts shown supporting the roof apart from those used in the NE gable as described above. This is based on the fact that there is no evidence for post holes within the structures and there has been no excavation across any of the NE gables. Taking into account the thin soil layer which has been subject to bioturbation, and the underlying Karst geology, both of these create problems when trying to identify post hole remains. Unfortunately, almost all the sites surveyed and those excavated in our area are on this type of ground,

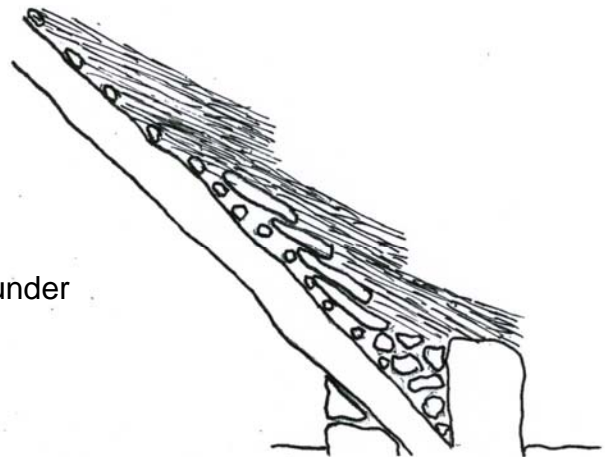
Fig 5 Detail of eaves showing turves under  
rush thatching.

The drawing in Fig 5 shows spars running up from the centre of the base wall to a ridge (Fig 6) going from the top of the SW hipped roof section to the NE gable end where the end spars are supported by the vertical posts and cross timber. We have shown cross members below the ridge tying opposing spars on either side of the roof together, in effect creating an A frame, that adds considerable strength to the roof and compensates for the possible lack of vertical post support.

The drawing (Fig 5) shows a possible reconstruction of the junction where the roof meets the wall, with turves placed on the roof under the thatch. There are two sound reasons for proposing this method of construction. First, it protects the interior, underside of the thatch from livestock damage and, secondly, the turves add weight at the base of the roof, helping to anchor it down into the wall where stones placed over the roof timbers are also adding weight. The drawing in Fig 6 shows the proposed construction of the ridge A frame the location of the horizontal timber is obviously adjustable up and down.

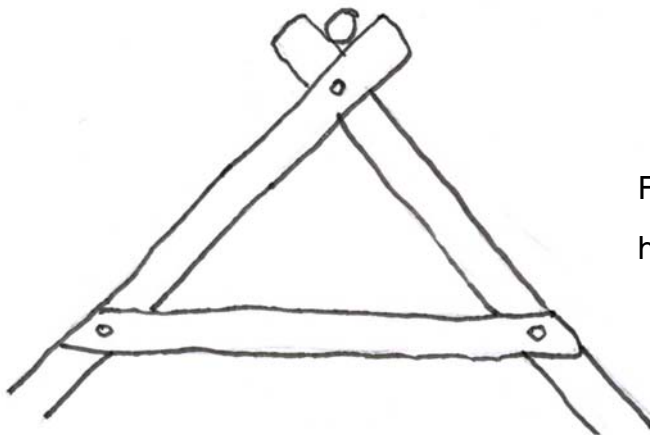
Fig 6 Ridge. A frame construction using  
half lap joints secured with wooden pegs .

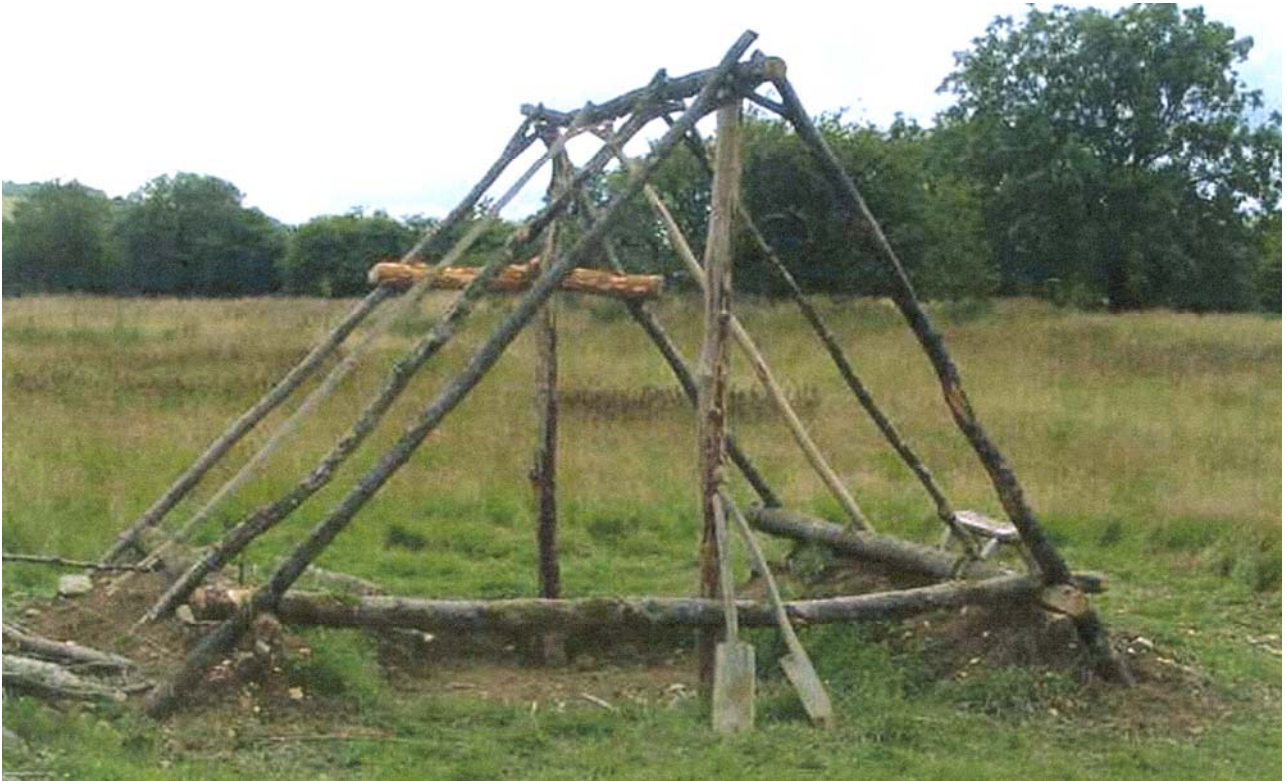
Plate 1. Showing framework of reconstructed Anglo-Saxon Structure.

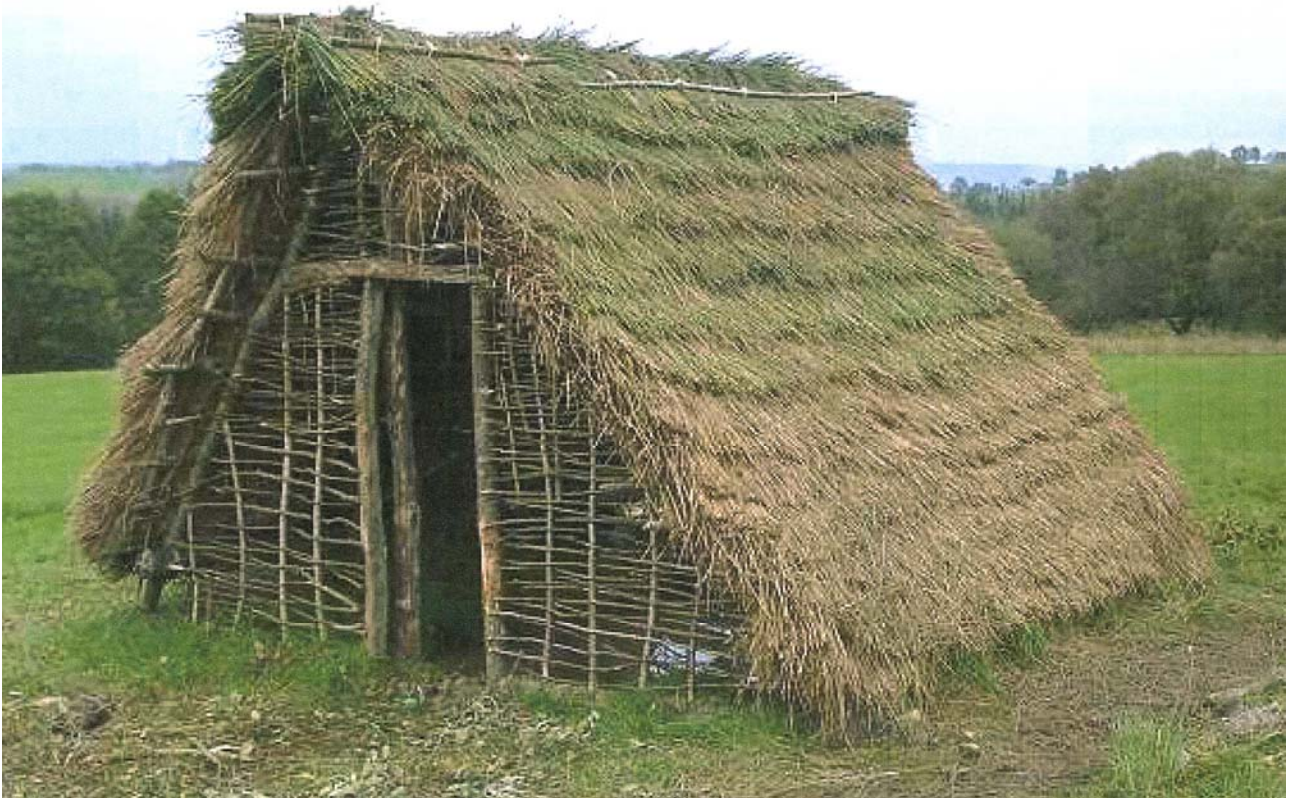
Plate 2. Showing Rush thatching and wattle in-filled gable.

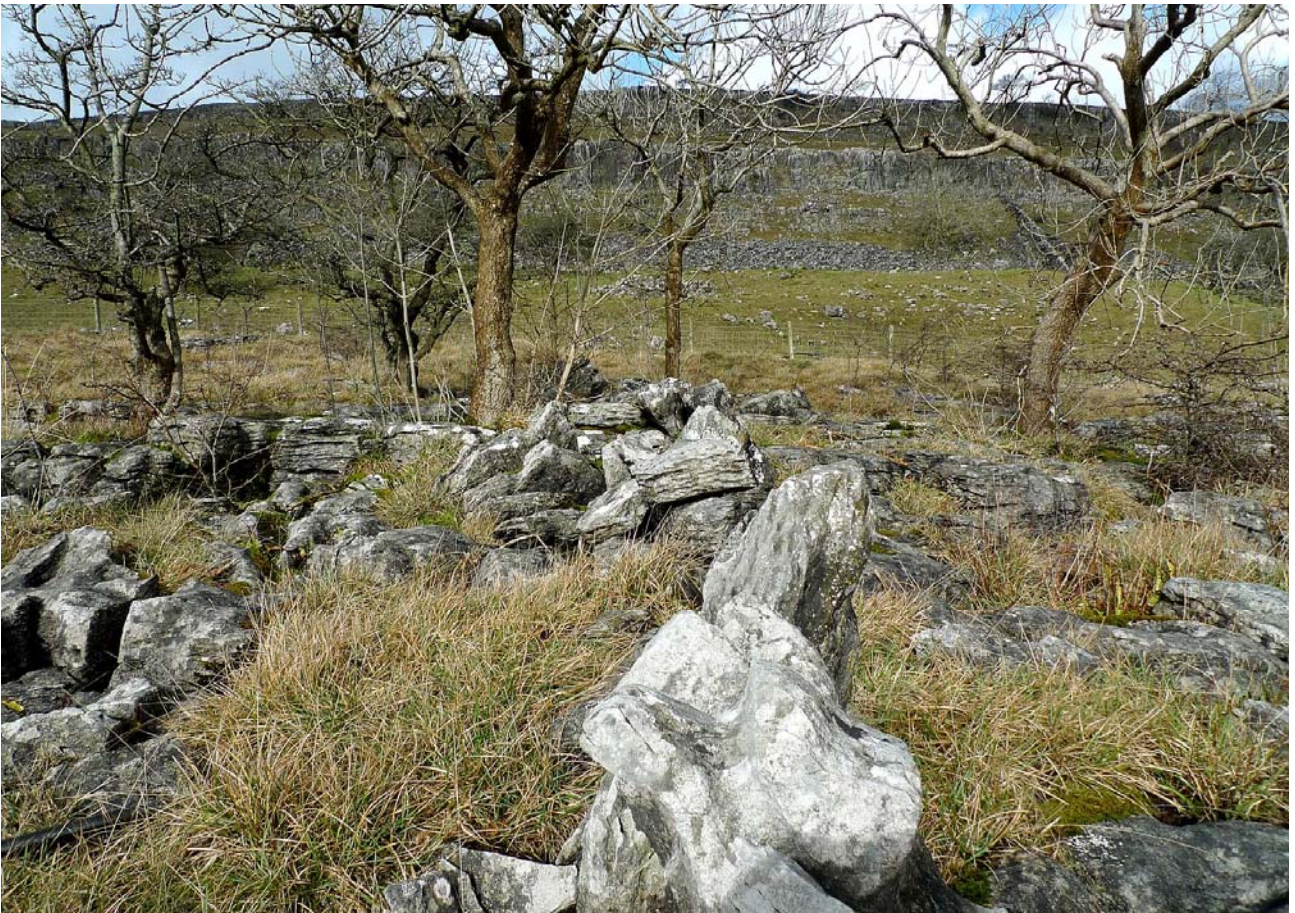
Plate 3. Stone base remains of brushwood fence SW enclosure. *Photograph A Batty*

At the SE end of the SW outer enclosure is one of the best examples of stone based enclosure remains we have seen (Plate3). There would probably have been timber posts

fixed in the grykes supporting brushwood on top of this stone base.

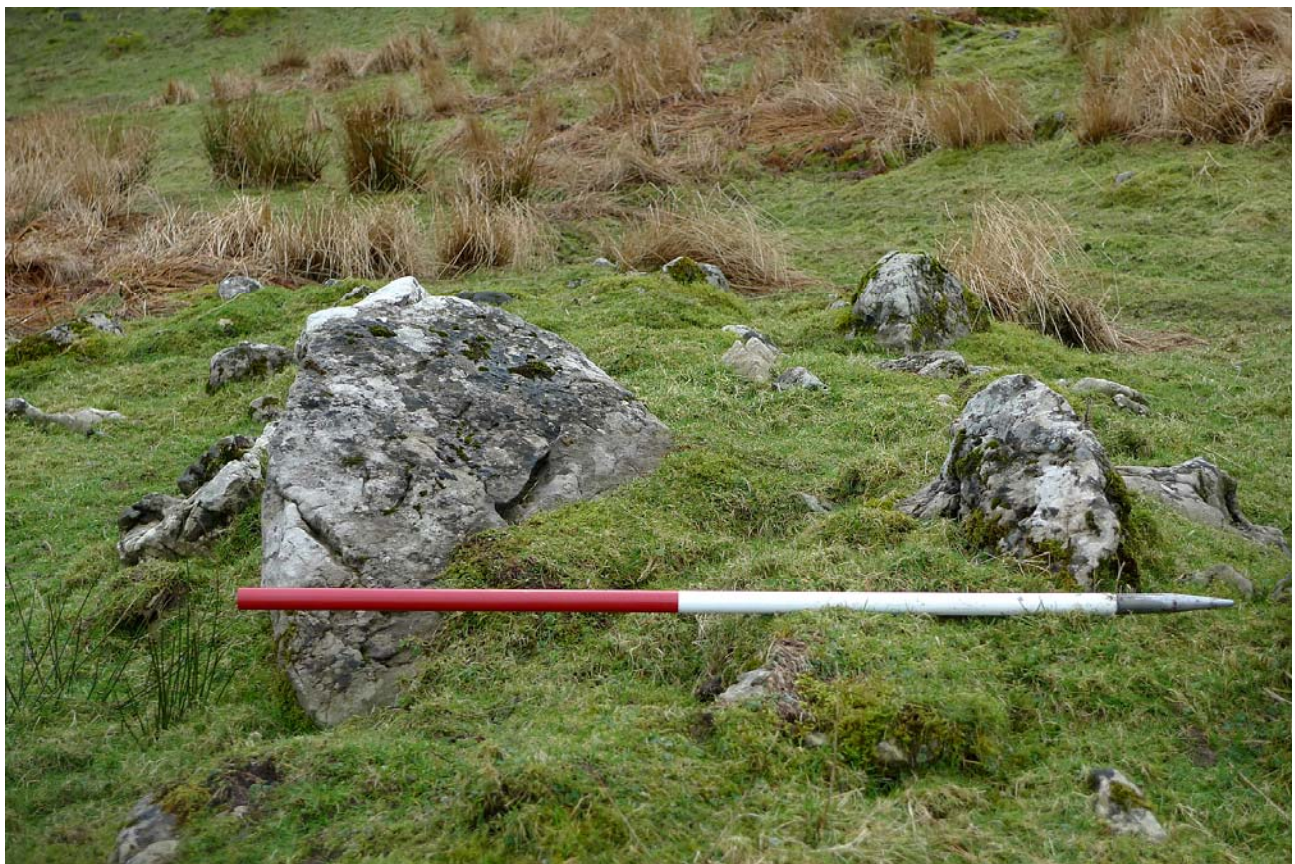
Plate 4. Showing 1m width of wall foundation Structure 1. area 1. *Photograph A Batty*

The overriding questions about the wall concerns the height and the construction methods. The approximate width of the wall remains on the Brows Structures is 1m (Plates 4 and 5) Many Anglo-Saxon buildings have been excavated further south in the country with only a few in the north and there is considerable evidence for these being built with timber uprights and timber boarded walls. There are examples of several structures built to this design at Thirling in Northumberland (O'Brien C, Milet R. 1991) and also at Yeavinger Bell (Hope-Taylor, B K 1977). The residents at these locations may actually be full-blooded Saxons, a premise we are unable to ascertain in our area, and this fact alone may create cultural differences resulting in different building techniques. Combined with the different geological and topographical location this makes it pointless to transpose their constructional methods onto the Brows pasture site.

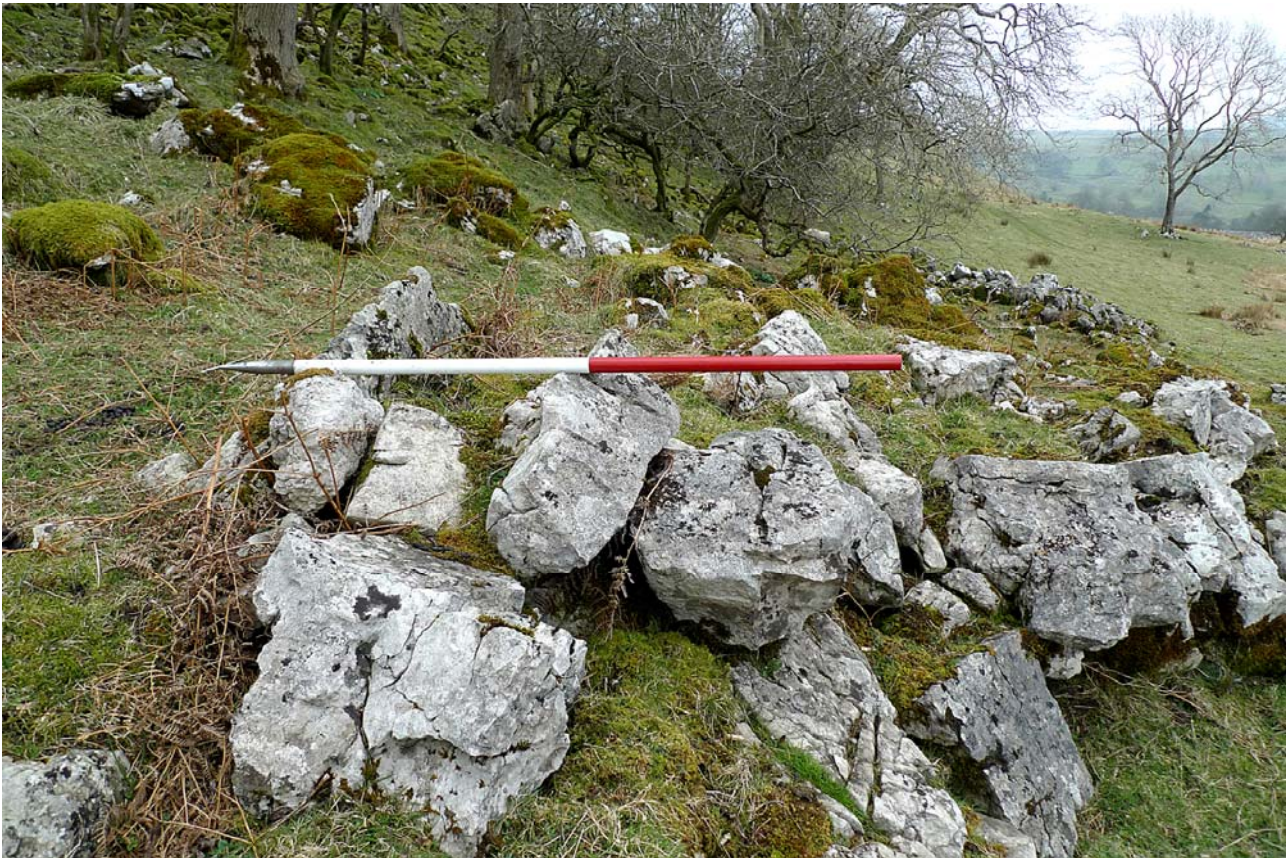
Plate 5. Showing 1m width of wall remains in Structure 2. area 2. *Photograph A Batty*

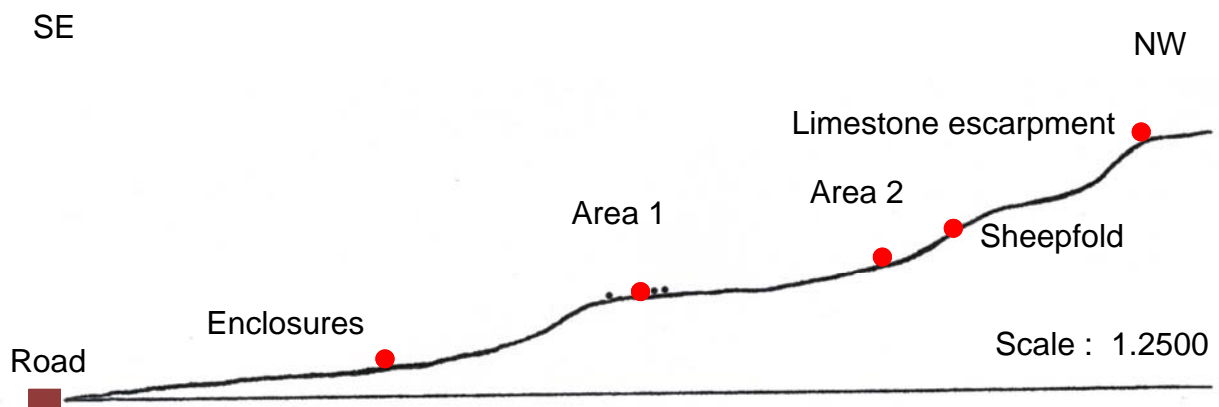
Fig 7 . Vertical profile of NW side of Brows Pasture.

The investigation covers three rectangular stone based structures; Structure 1/Area 1 (Fig 2) and Structures 1, and 2/Area 2, (Fig 3). The splitting of these two groups of structures into two areas is not meant to imply that they are two separate farmsteads. There is no clear evidence from enclosure remains on the survey (Fig 1) or excavation that they are two separate farmsteads, unlike the two sites in Clapham Bottoms that have clearly defined associated field systems (Batty A 2011). However, even these may not be individual farmsteads but are probably more likely to represent different agricultural stock or crop regimes. A cross-section of the NW side of the valley (Fig 7) shows the elevation relationship between the different feature locations.
